Report on Communal Entrance Door Repairs

Kingsway Gardens, Andover.

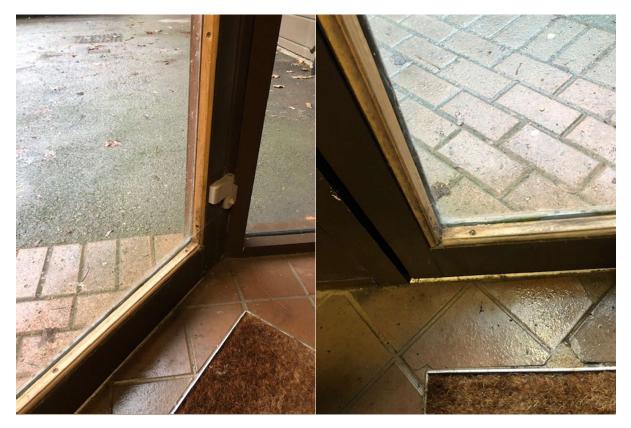
Block 5-12 Stuart Court

Glazing beads replaced with softwood and hardwood to internal/external side. Renew glazing beads if possible.

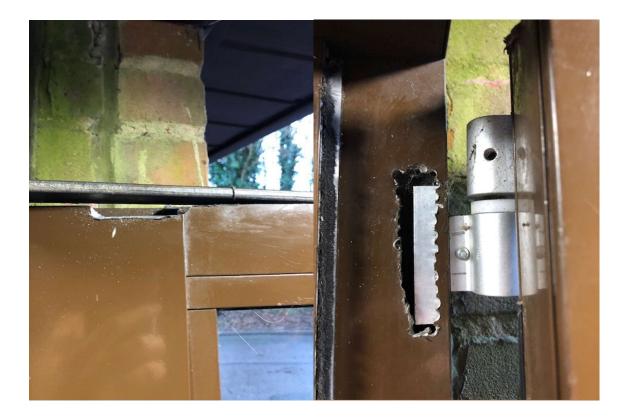
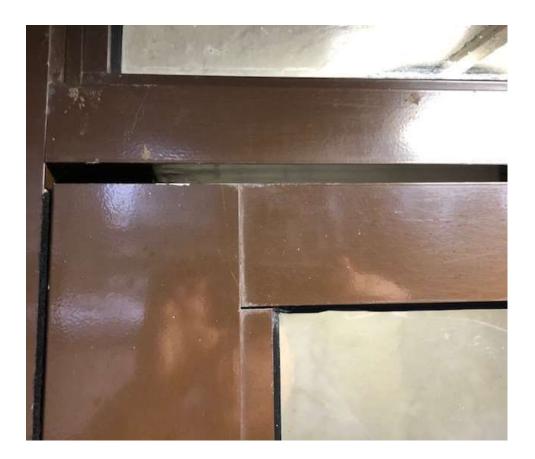
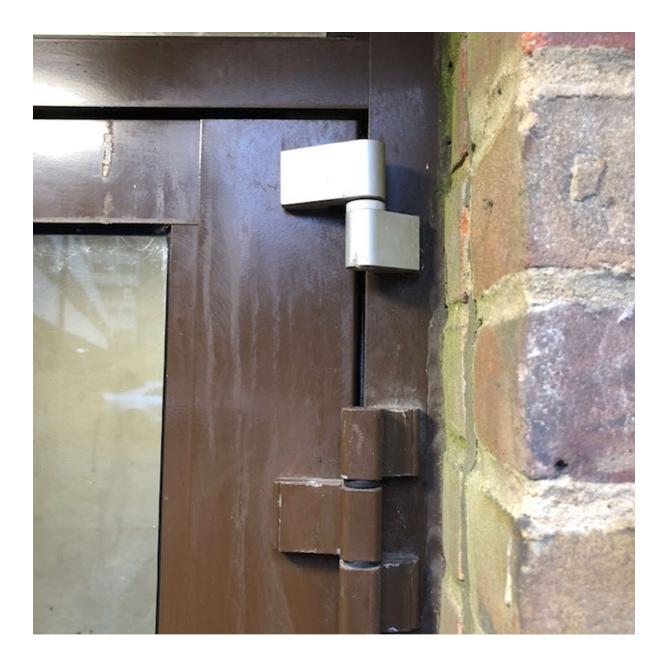
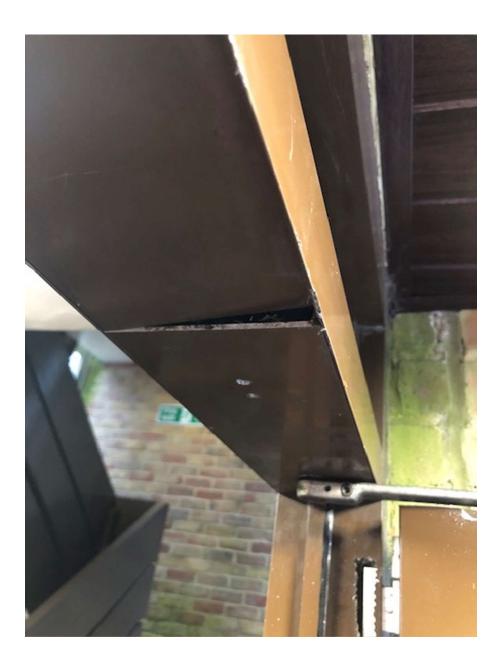
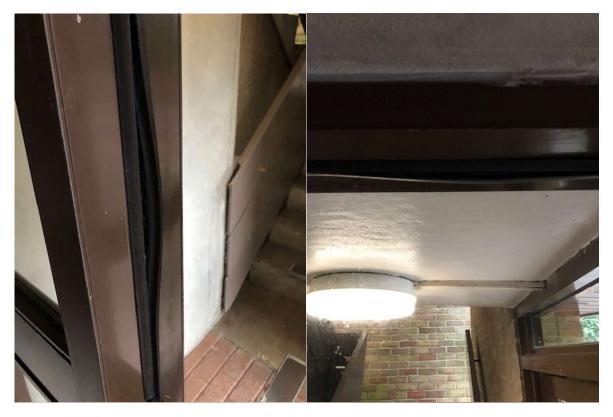
Block 1-4 York Court and Block 21-24 Tudor Court (One System)

Door frame has had additional hinge fitted as door has dropped, damage to top of door frame. No thumb-turn present, relying on push to exit button. Glazing beads to door and side panels in poor condition. Panel to intercom in poor condition. Replace door and side panels.

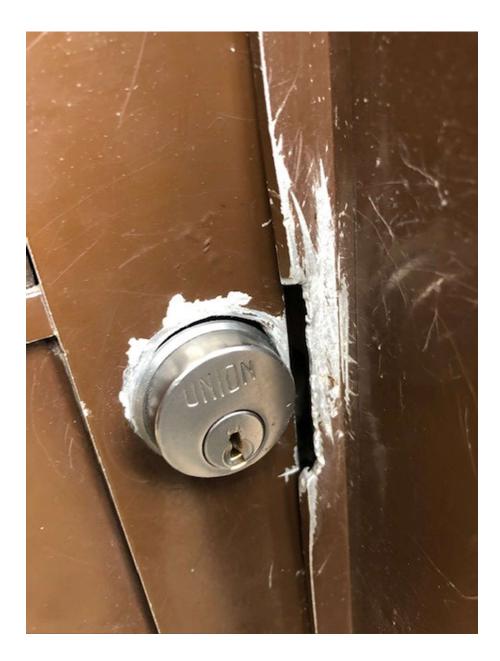
Block 13-20 Saxon Court

Door not secure, strike not engaging.

Lock appears to have been forced, door closer catching on the top of the door. Door closure needs renewing.
