Project Name: Moat Court Report
Project Description: CCTV Survey
Project Number: DRQ2983
Project Date: 04/09/2020
Inspection Standard: MSCC5 Sewers & Drainage GB (SRM5 Scoring)

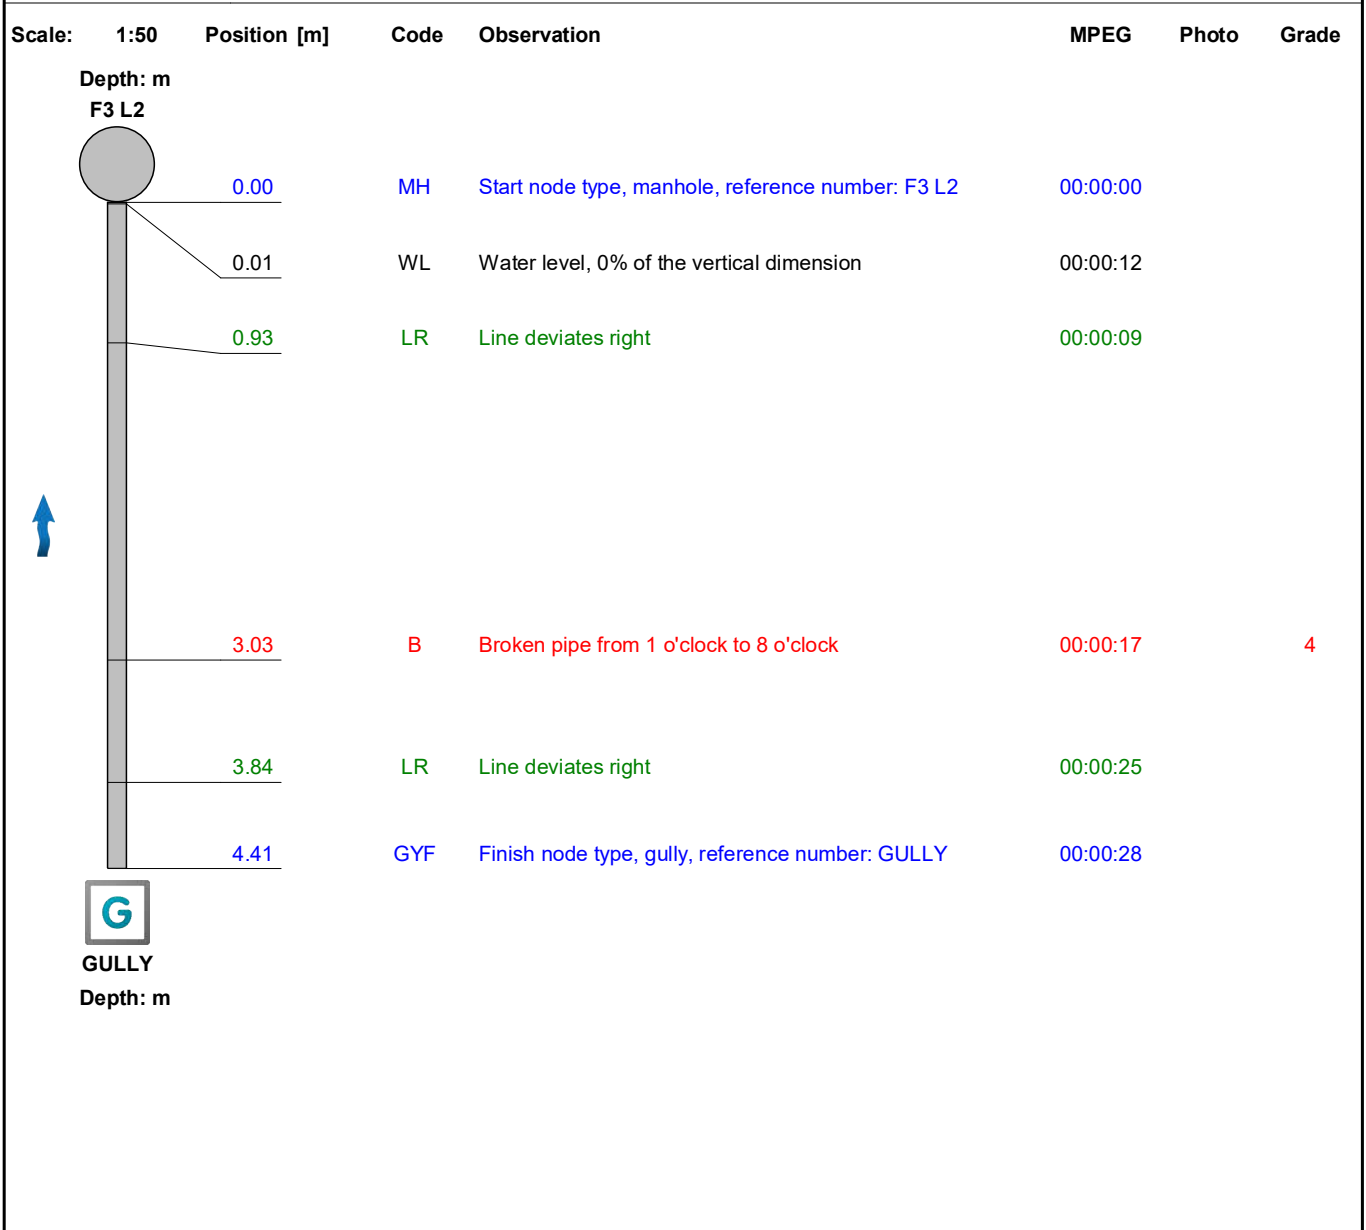
Section	PLR	Grade	Description
10	GULLYX	4	Broken pipe from 1 o'clock to 8 o'clock

Construction Features					Miscellaneous Features				
Structural Defects					Service & Operational Observations				
STR No. Def	STR Peak	STR Mean	STR Total	STR Grade	SER No. Def	SER Peak	SER Mean	SER Total	SER Grade
1	80.0	20.8	80.0	4.0	0	0.0	0.0	0.0	1.0
