October 2020

REPORT ON INTERCOM ENTRY SYSTEMS

KINGSWAY GARDENS, ANDOVER

ASTER GROUP LIMITED

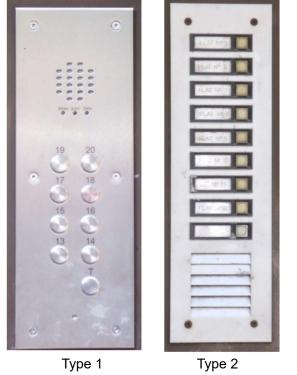
2.2.1 On the above blocks there was five different models of intercom panels.:

2.2.2 The make of the Type 1 panel is Videx, vandal resistant Type VR120/136, the Type 3 are Videx 8000 series units, the other units are unknown. The above photographs were sent to BPT, thought to be the supplier of the Type 2 panels, but BPT replied that none of the above were BPT units. The Type 2 panels are likely to be the original panels installed.

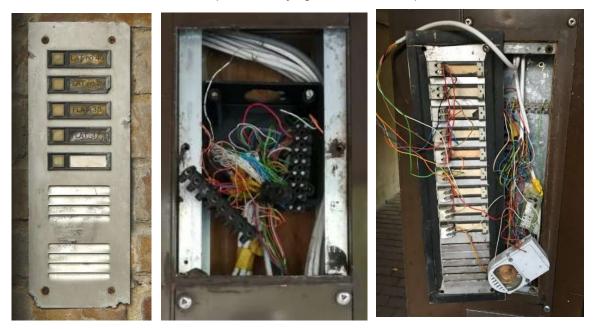
2.4.2 The condition and quality of the installations seen was very poor. No cable management was identified with wires and cables loose within the units. Modifications like added amplifiers are lying loose within the panels
